MANUFACTURING METHODS TECHNOLOGY
(MM AND T) FOR BALLISTICALLY TOLERANT
REPLACEMENT FLIGHT CONTROL COMPONENTS

Whittaker Corporation

Army Air Mobility Research and
Development Laboratory

July 1974

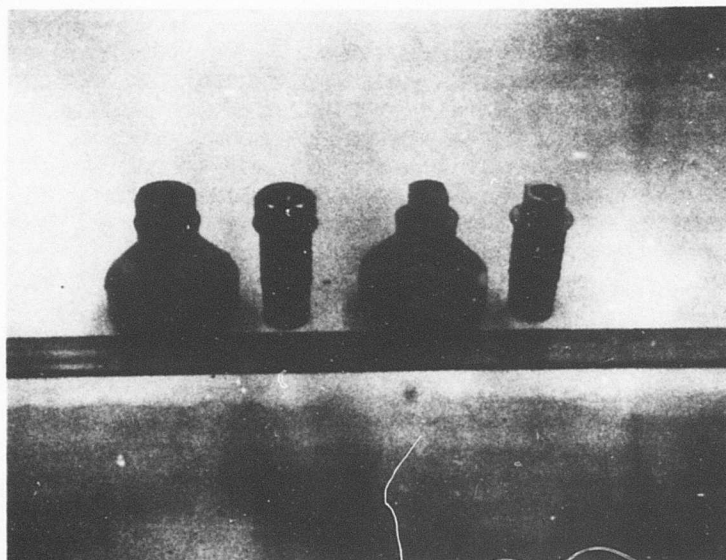
Figure 10. Completed End Fittings for
Connecting Link.

The end fittings were fabricated by molding the BMC material, the continuous glass preform, and the metal attachment insert in one molding operation. First, the continuous glass reinforced insert was prepared by die cutting three patterns of glass/epoxy prepreg. These plies were then formed around a Teflon mandrel and inserted inside a Teflon female tool for staging and forming at temperatures of approximately 150°F for 45 minutes (see Figures 7 and 8). The preforms were then removed from the forming tools and placed in the compression molding tool along with the metal attachment insert. Following the insertion of these two details into the preheated tool, the BMC charge is added as bulk material. This is shown in Figure 9. The assembly is then molded and cured. Two fitting details are required for each connecting link, each having a different attachment fitting configuration. The molded fitting detail is shown in Figure 10.
